WT-1408

# OPERATION PLUMBBOB

Project 1.8b

EFFECTS of ROUGH TERRAIN on DRAG-SENSITIVE  
TARGETS (U)

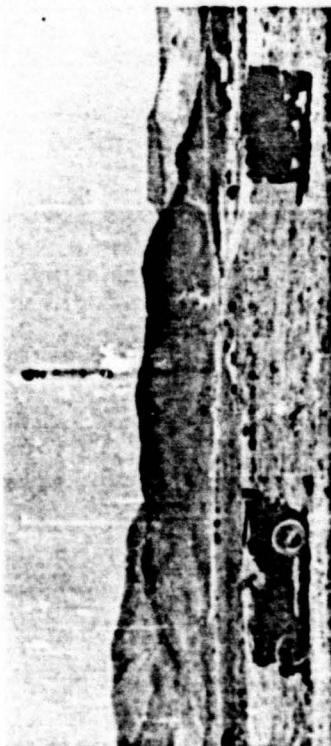
Figure 2 Line 1, looking toward ground zero.

The control line was designated as Line 1 (Figure 1). The terrain on Line 1 was essentially flat, although there was a slight downward slope away from ground zero. There were five vehicle stations along this line (Figure 2). Each station consisted of two vehicles, one oriented side-on (SO) toward ground zero and the other face-on (FO). At each of the second and fourth stations (6.02 and 6.04), a revetment was constructed. This was simply an earth mound approximately 7 feet high (Figure 3). One side-on vehicle was placed behind each of these revetments.

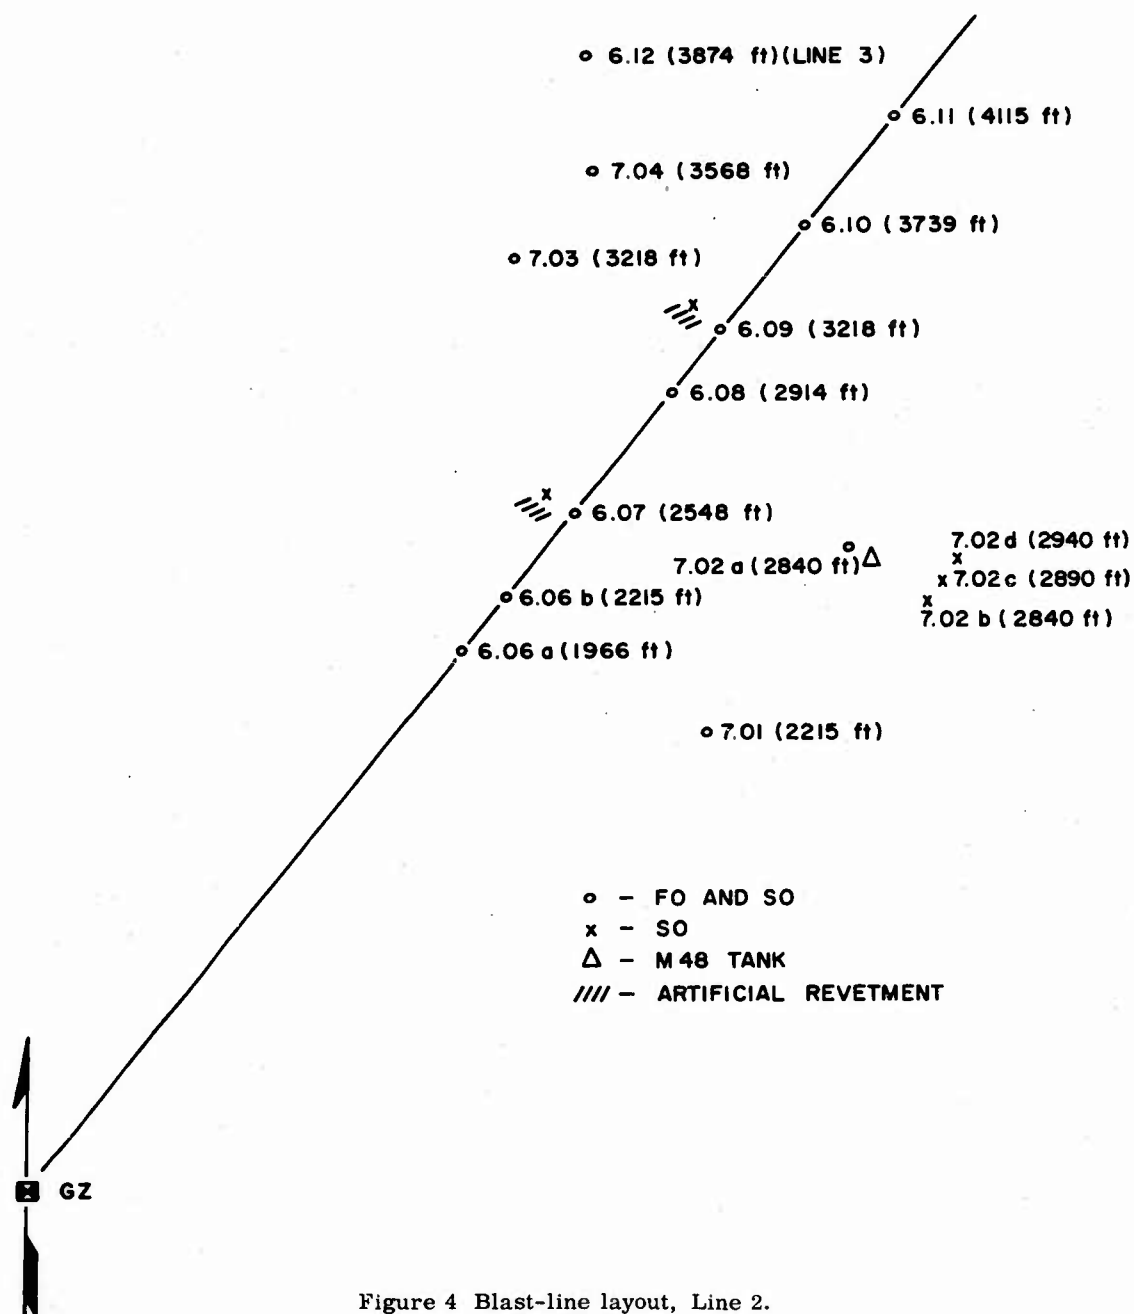
Figure 4 Blast-line layout, Line 2.

The area around Line 2 was of particular interest (Figure 4). Twenty-nine vehicles were employed on the tops of hills, down in the dales, and in various shielded positions. There were seven stations directly on Line 2 each having a side-on and face-on jeep. Stations 6.07 and 6.09 also had revetment stations. Two stations (7.03 and 7.04) were established on one side of Line 2 to provide a shielded station (7.03) for comparison with a hill station (6.09) at the same range and a hill station (7.04) for comparison with a dale station (6.10) at roughly the same range. On the other side of Line 2, Station 7.01 was a hill station at the same range as Station 6.06b, a dale station. Station 7.02a was directly behind a steep hill and was at the same approximate range as Station 6.08, which had much less protection.

One station (6.12) consisting of a side-on and face-on vehicle was placed on a hill at the end of Line 3 of Project 1.8a (Figure 4).

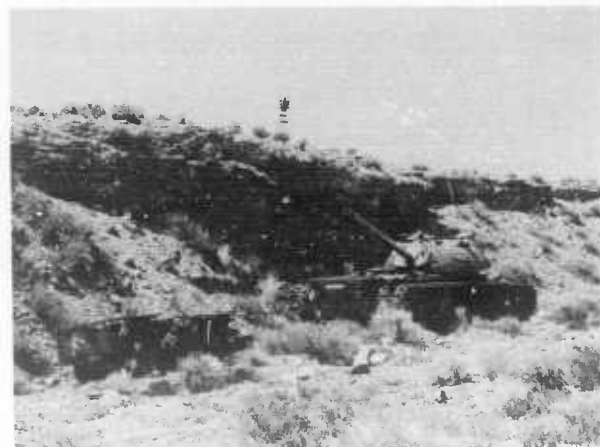
Figure 5 Station 7.02(b), Line 2.

At one location near Line 2 (Station 7.02b, c, and d) there was a steep bluff (the bank of a wash) behind which were placed three jeeps and an M48 tank, all side-on (Figure 5). This wash, or gully, was approximately 100 feet wide. One jeep and the tank were placed against the bluff, one jeep was placed midway in the wash, and the other jeep was placed against the far bank of the wash. This configuration was expected to ascertain the degree of protection which might be obtained at a given distance from a wall. The information would be of value in choosing a most advantageous position when the detonation point cannot be predicted.

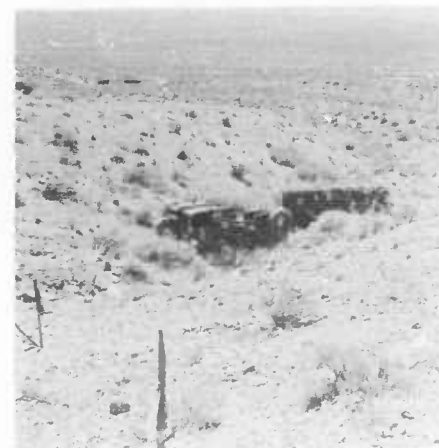
Figure 6 Station 7.07, Line 5.

Line 5 was the term used to identify the general location of a group of five widely scattered vehicle stations to the northwest of ground zero (Figure 6 and 7). These stations were placed to investigate natural terrain features such as a gully (Stations 7.07 and 7.08), a ravine (6.13), a wash (7.05), and the back of a hill (7.06).

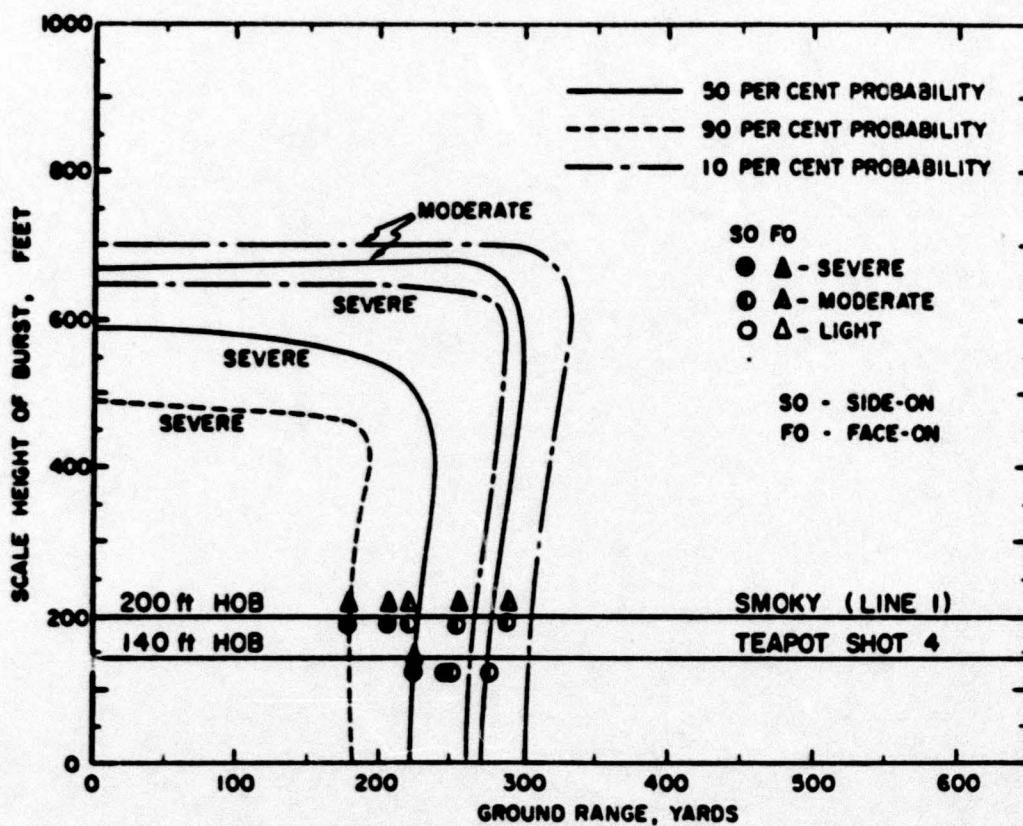
Figure 12 Comparison of Smoky Line 1 with Teapot Shot 4 and the Damage Chart of TM 23-200 scaled to 1 kt.

Figure 12 compares the damage sustained by the vehicle stations along the control line with that predicted by the TM 23-200 vehicle-damage chart. Data from another NTS shot of the same yield (Teapot, Shot 4, 43 kt at a height of burst of 500 feet is also plotted on this chart. The comparisons show that the control line results were typical for an NTS shot over level terrain both with respect to the TM 23-200 damage chart and the NTS shot of similar yield. (Note: The TM 23-200 chart was revised since this data was compiled; however, the revised material, at the height of interest, was only slightly altered.)

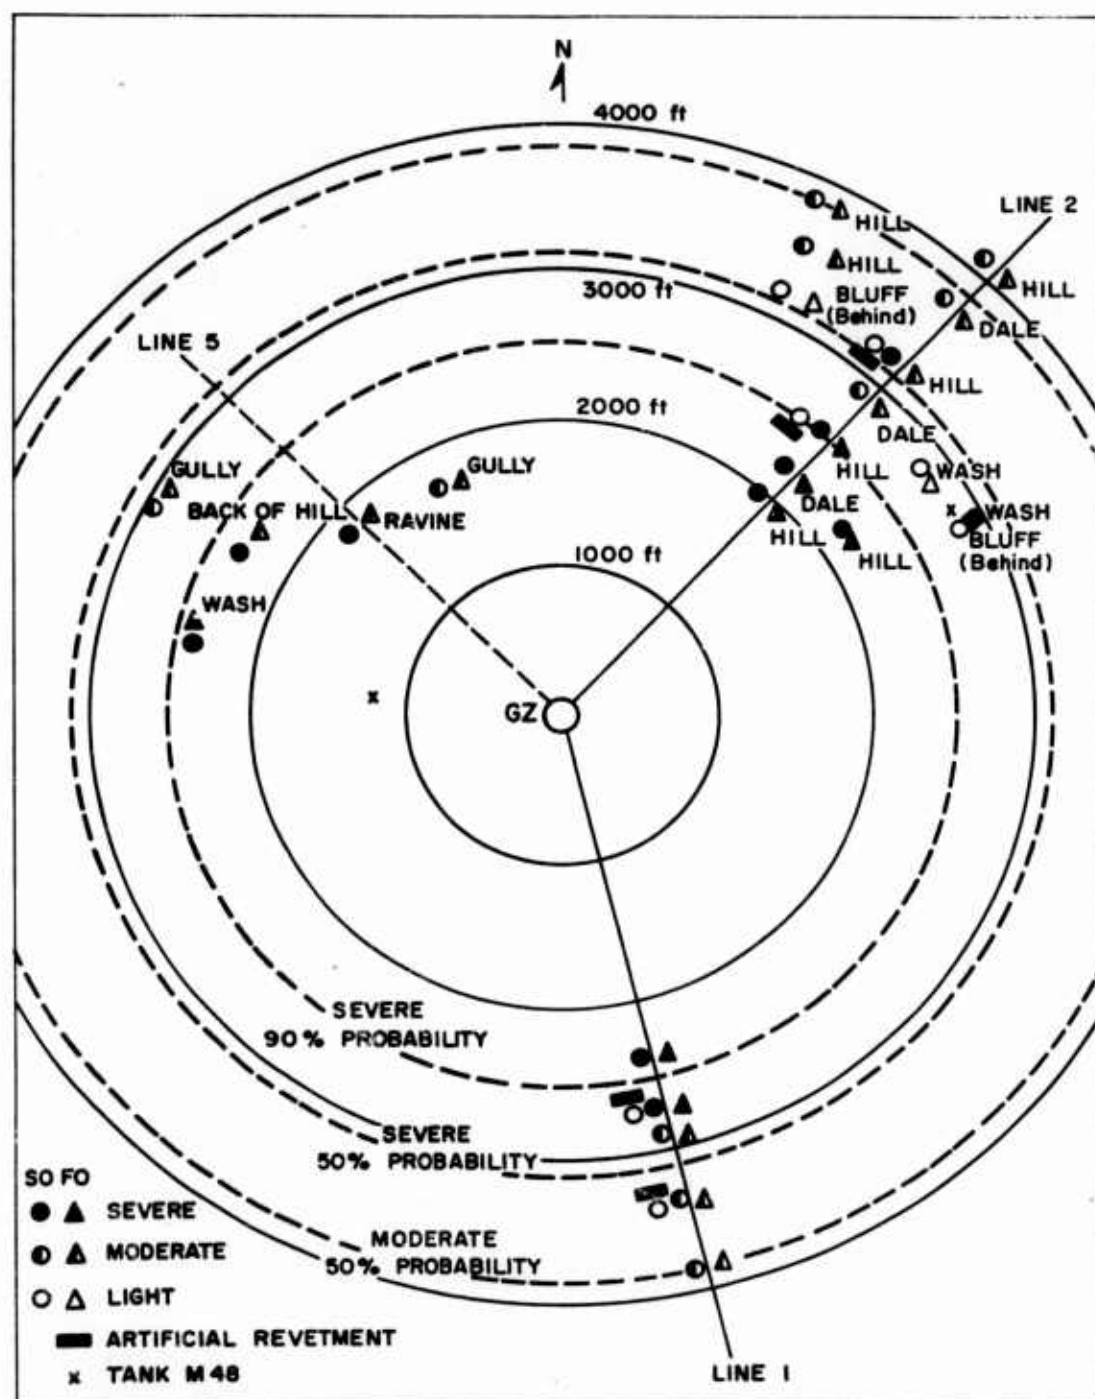
Figure 13 Layout of vehicle stations and resulting damage for Shot Smoky.

Figure 13 shows the damage sustained by all vehicle stations and designates the type of terrain at the station location. This information is shown on a polar plot in order that the various stations can be compared directly. The damage probability contours of TM 23-200 have been scaled to shot conditions and are shown in Figure 13 so that comparisons of actual and predicted damage can be made.

As shown in Figure 13, the damage experienced by the vehicles directly on Line 2 was identical at corresponding distances on the control line, with one exception. The side-on vehicle at Station 6.09 (a hill station) was severely damaged, while the vehicles in front of this station, as well as those equal distances on the control line, were only moderately damaged. Although severe damage is implied at this ground range, it is unusual to have those vehicles (surrounding and preceding the severely damaged vehicle) sustain only moderate damage.

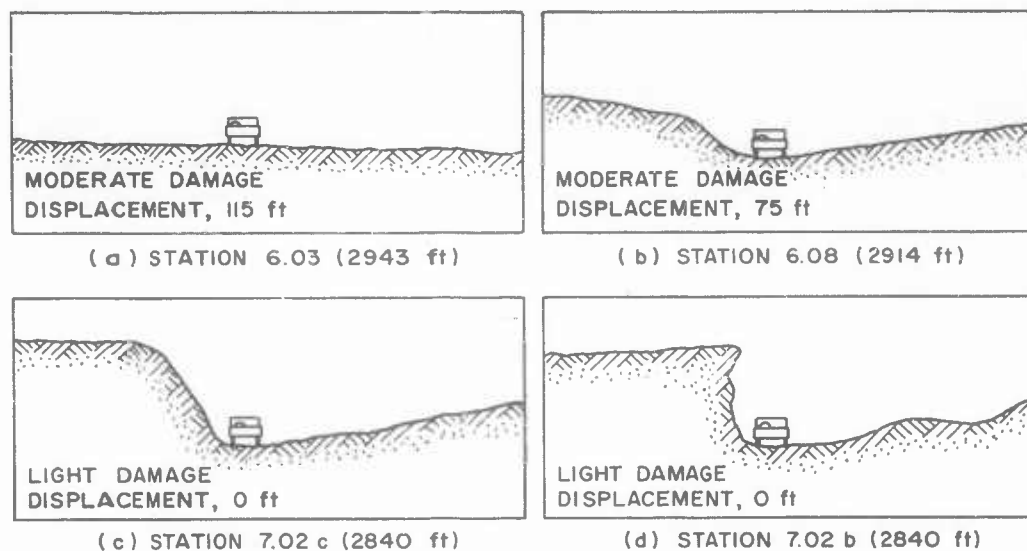
Figure 14 Terrain profiles for vehicle stations.

The comparison of Stations 6.03, 6.08, and 7.02 in Figure 14 shows that, at about the same ground range, significant reduction in damage was obtained when proper advantage was taken of existing terrain accidents. The vehicle at Station 6.03 (2,943 feet) on the control line was displaced 115 feet, sustained moderate damage, and would have required about 12 hours of maintenance work to restore to combat usability. The corresponding vehicle at Station 6.08 (2,914 feet) on Line 2 was displaced 75 feet and sustained moderate damage requiring 4 hours maintenance time. Those vehicles at Stations 7.02a and 7.02b were not displaced and only lightly damaged, requiring no repair time.
